96-18-22 ROBINSON HELICOPTER COMPANY : Priority Letter issued August 29, 1996.  
Docket No. 96-SW-25-AD.

Applicability: Model R44 helicopters, with main rotor gearbox (gearbox), part number (P/N) C006-1, Revisions A through P, installed, certificated in any category.

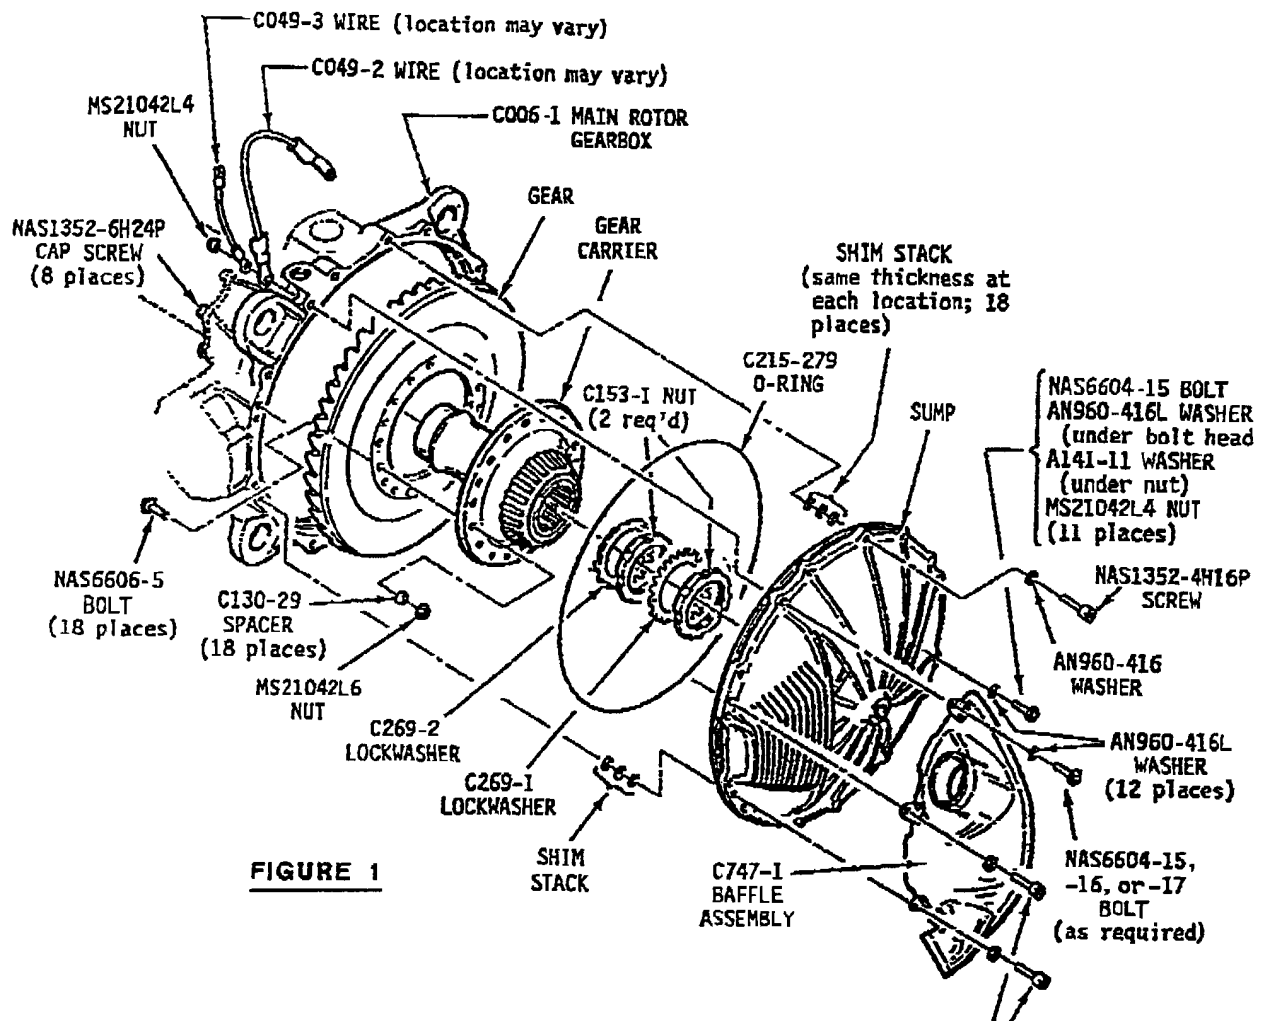
**FIGURE 1**

(b) Lay the gearbox on its side with input yoke up. Loosen the eight cap screws attaching the mast tube to the gearbox, but do not remove the screws. Remove the twelve bolts and six cap screws holding the sump and baffle in place (Figure 1). Note the location of ground wires.

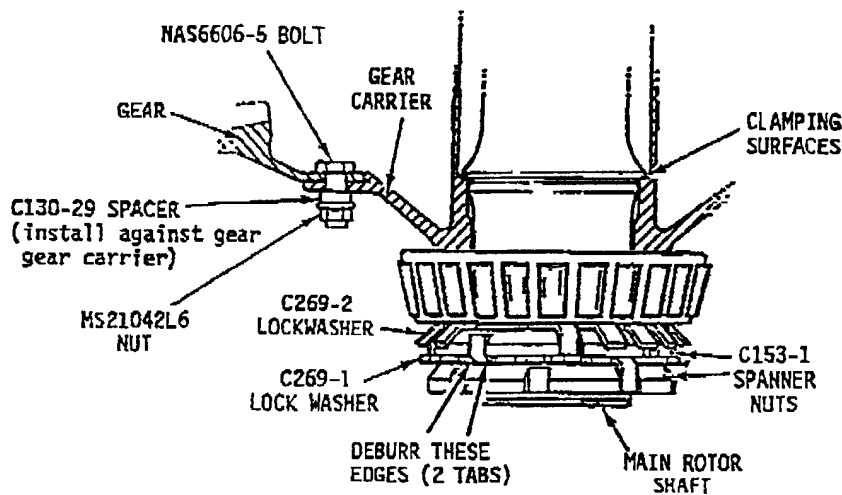
**FIGURE 2**

(h) Align the gear to the gear carrier and install NAS6606-5 bolts, spacers, P/N C130-29, and MS21042L6 nuts in 18 places (Figure 2). Keep the mating surfaces and hardware dry, clean, and free of oil. Torque the nuts to 40 ft.-lb. (includes self-locking torque) using the torquing sequence shown on Figure 3.

(l) Before installing the unused lockwasher, P/N C269-1, note that the edges are sharp on one side and rounded on the other. De-burr the sharp edges on two opposite tabs (Figure 2). This will reduce the chance of cracking when these tabs are bent. Install the lockwasher with the de-burred edges toward the first nut.
